## 20.44-ACRE ROTHROCK COMMONS PROPERTY TREE PLOT DATA

20.44-ACRE ROTHROCK COMMONS PROPERTY  
COPLEY TOWNSHIP, SUMMIT COUNTY, OHIO  
CEC PROJECT 318-488

PHOTOGRAPHS TAKEN ON: JANUARY 19, 2022

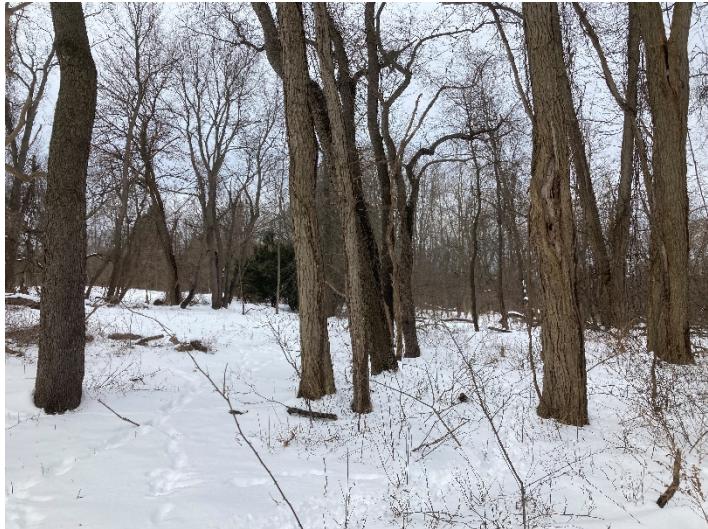
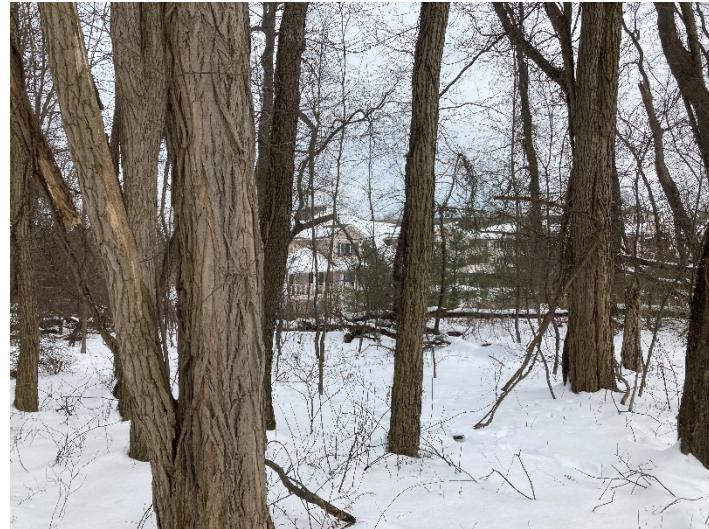
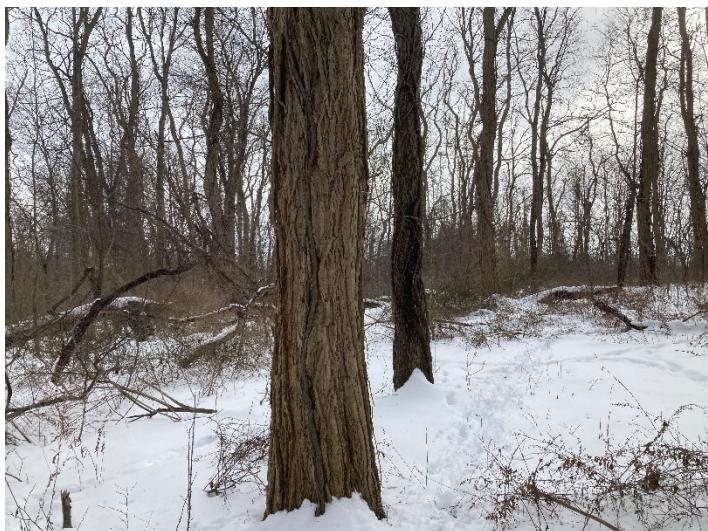
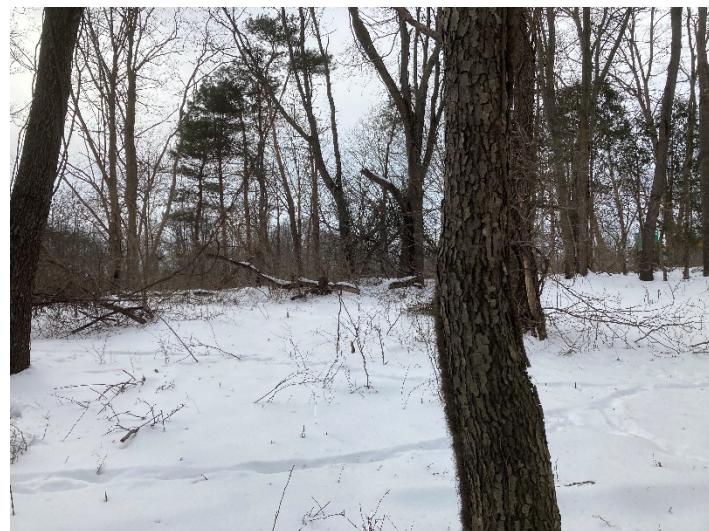
PLOT	TREE SPECIES (Latin)	TREE SPECIES (common)	DIAMETER AT BREAST HEIGHT (DBH, IN)	DRIPLINE RADIUS (FT)	TREE CONDITION	TREE CONDITION NOTES	GENERAL NOTES
1	<i>Prunus serotina</i>	Black Cherry	10	5	Fair	vines, slight lean	Plot 1 (Woodland) exhibited poor to good conditions and was dominated by black locust and black cherry, which made up more than 50% of the total canopy coverage. The understory (<6" DBH) was primarily comprised of 0.5" to 1" DBH <i>Fagus grandifolia</i> (American beech). See Photographs 1-4.
	<i>Prunus serotina</i>	Black Cherry	14	20	Fair	vines, dead limbs (prune to maintain)	
	<i>Prunus serotina</i>	Black Cherry	12	10	Fair	vines, poor structure	
	<i>Prunus serotina</i>	Black cherry	21	15	Poor	bark damage, dead limbs, poor structure, remove tree	
	<i>Prunus serotina</i>	Black cherry	20	25	Good	vines	
	<i>Prunus serotina</i>	Black cherry	11	10	Good	vines	
	<i>Prunus serotina</i>	Black cherry	18	20	Fair	vines, dead limbs (prune to maintain), slight lean

**Photo 1:** Overview of Plot 1 (Woodland), facing north.

**Photo 2:** Overview of Plot 1 (Woodland), facing east.

**Photo 3:** Overview of Plot 1 (Woodland), facing south.

**Photo 4:** Overview of Plot 1 (Woodland), facing west.

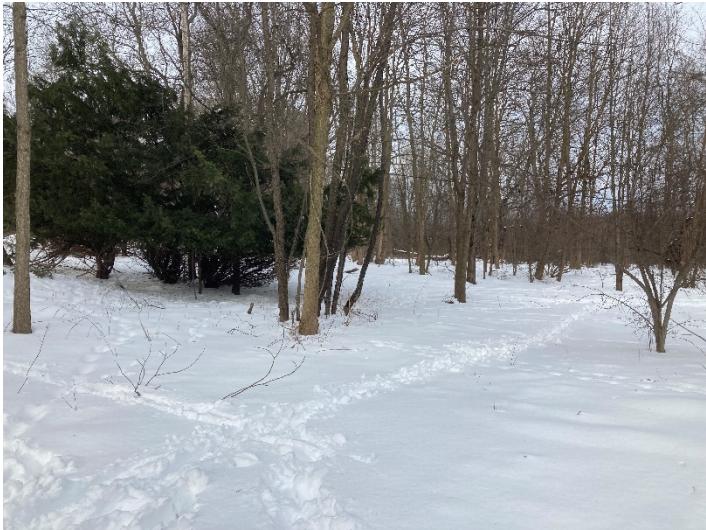
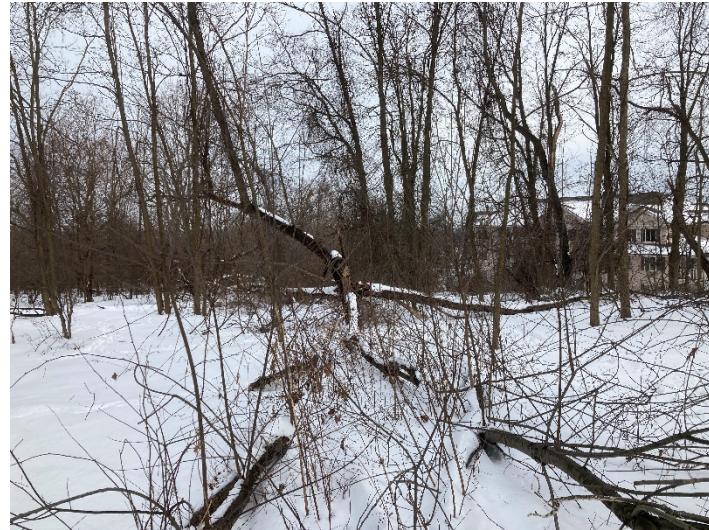
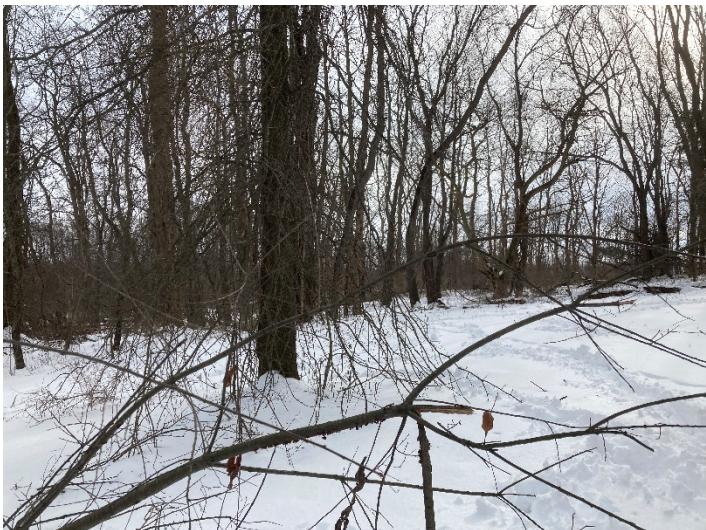
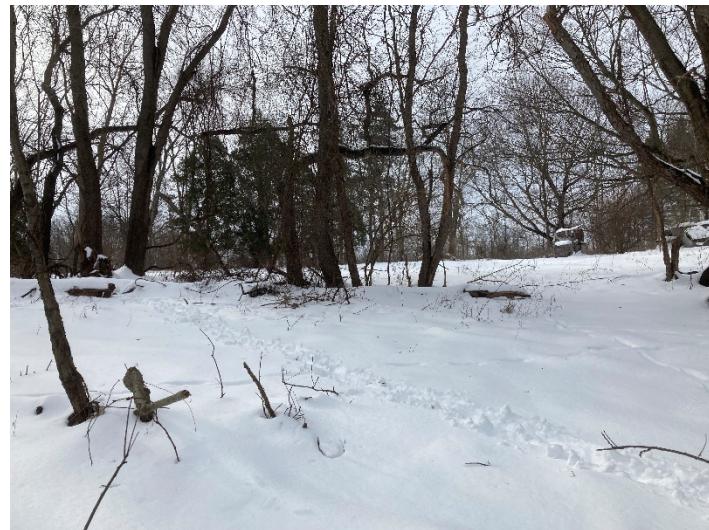
**Photo 5:** Overview of Plot 2 (Non-Woodland), facing north.

**Photo 6:** Overview of Plot 2 (Non-Woodland), facing east.

**Photo 7:** Overview of Plot 2 (Non-Woodland), facing south.

**Photo 8:** Overview of Plot 2 (Non-Woodland), facing west.

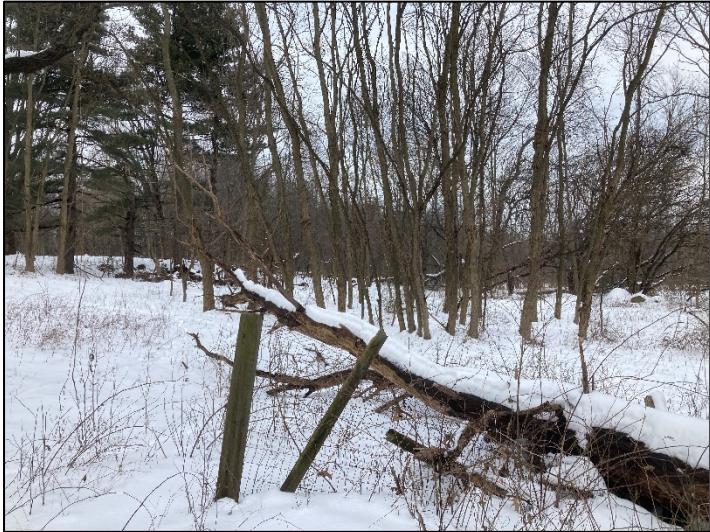
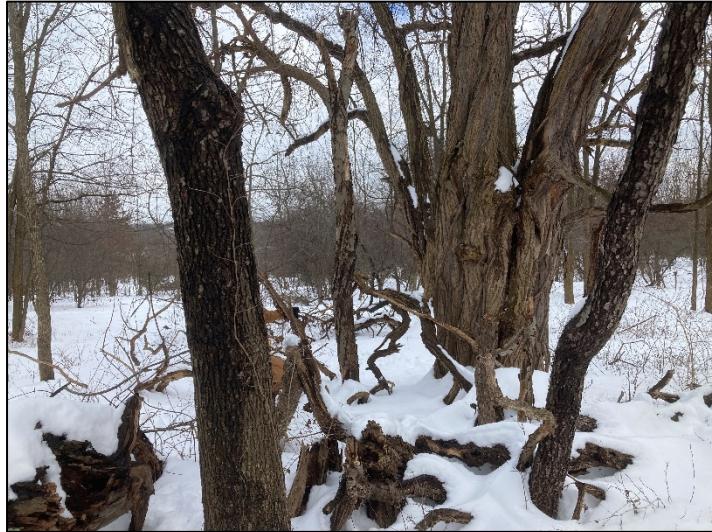
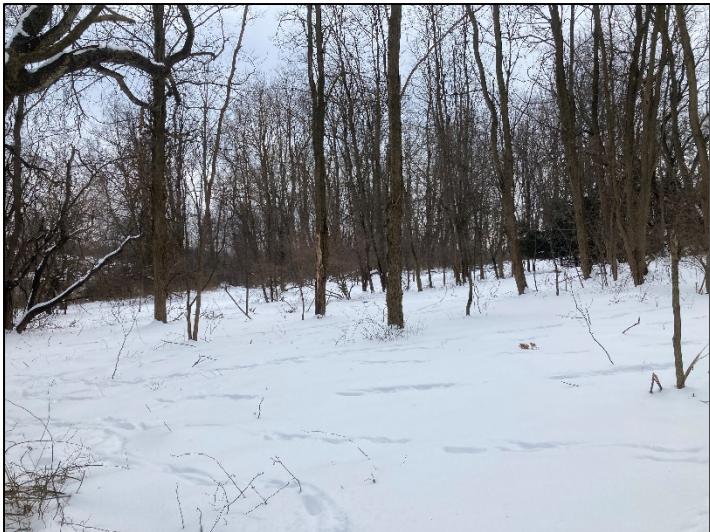
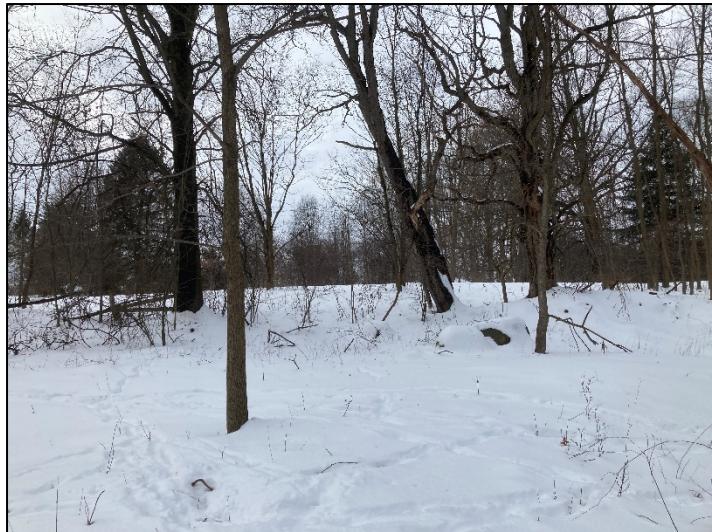
<i>Robinia pseudoacacia</i>	Black Locust	17	20	Fair	vines, dead limbs (prune to maintain)	
	<i>Robinia pseudoacacia</i>	Black Locust	25	20	Poor	vines, bark damage, dead limbs, cavity present, remove tree	
2	<i>Juglans nigra</i>	Black Walnut	8	15	Fair	vines, dead limbs (prune to maintain)	Plot 2 (Non-woodland) exhibited fair and good conditions and was dominated by an understory (<6" DBH) comprised of black walnut and black cherry approximately 3" to 4" DBH. Although Plot 2 had trees greater than 6" DBH, they did not make up more than 50% of the total canopy coverage. See Photographs 5-8.
	<i>Quercus palustris</i>	Pin Oak	15	22	Good	vines, low amount of dead limbs (prune to maintain)	
	<i>Robinia pseudoacacia</i>	Black Locust	11	18	Fair	vines, dead limbs (prune to maintain)	
	<i>Robinia pseudoacacia</i>	Black Locust	10	15	Fair	bark damage, dead limbs (prune to maintain)	
3	<i>Juglans nigra</i>	Black Walnut	7	20	Good	no noticeable conditions	Plot 3 (Woodland) exhibited poor and good conditions and was primarily dominated by black cherry, which made up more than 50% of the total canopy coverage. The understory (<6" DBH) was primarily comprised of <i>Rubus</i> sp. See photographs 9-12.

**Photo 9:** Overview of Plot 3 (Woodland), facing north.

**Photo 10:** Overview of Plot 3 (Woodland), facing east.

**Photo 11:** Overview of Plot 3 (Woodland), facing south.

**Photo 12:** Overview of Plot 3 (Woodland), facing west.

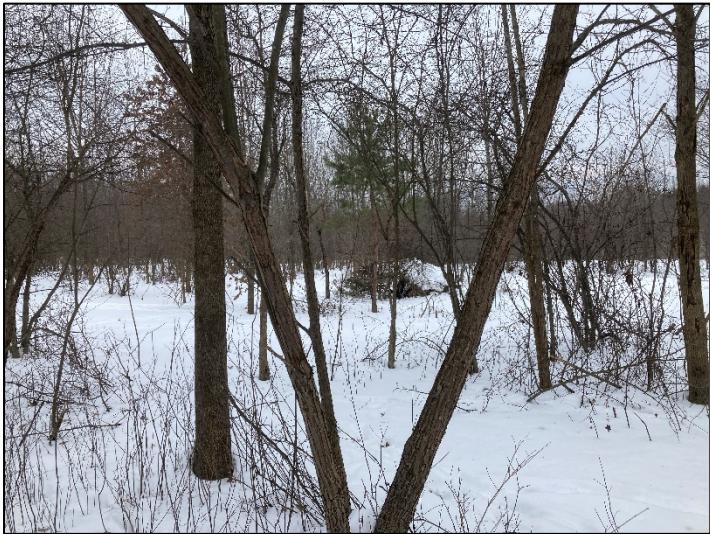
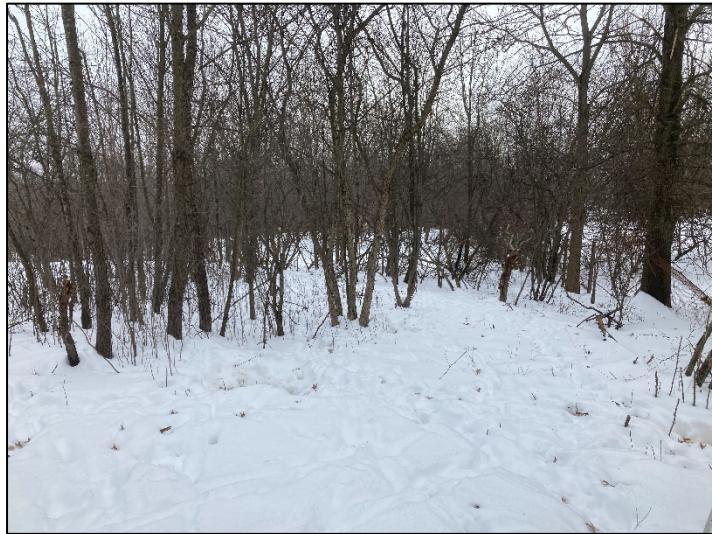
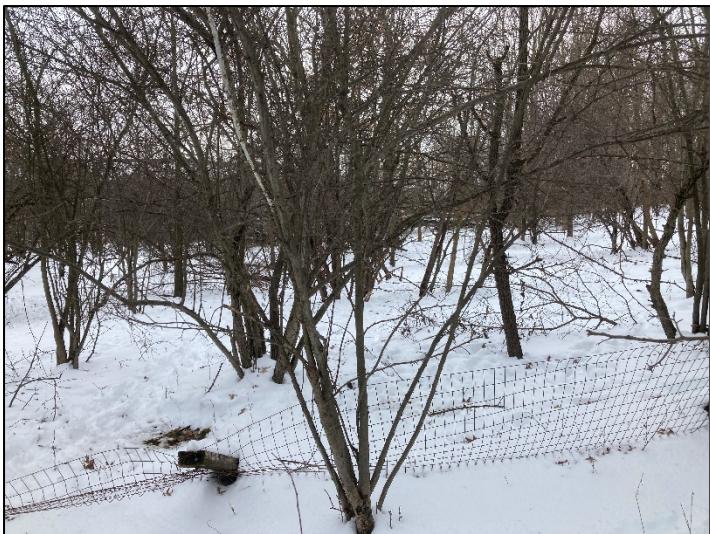
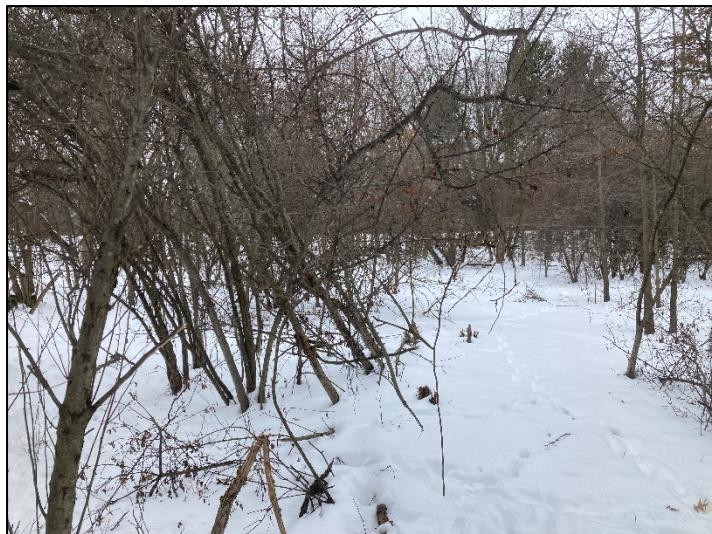
<i>Prunus serotina</i>	Black Cherry	17	18	Poor	vines, bark damage, dead limbs, poor structure, remove tree	
	<i>Prunus serotina</i>	Black Cherry	9	10	Poor	vines, dead limbs, poor structure, moderate lean, remove tree	
	<i>Prunus serotina</i>	Black Cherry	13	5	Poor	vines, bark damage, dead limbs, poor structure, moderate lean, remove tree	
	<i>Prunus serotina</i>	Black Cherry	8	8	Poor	vines, dead limbs, poor structure, remove tree	
	<i>Prunus serotina</i>	Black Cherry	21	15	Poor	vines, dead limbs, poor structure, moderate lean, remove tree	
	<i>Prunus serotina</i>	Black Cherry	28	25	Poor	vines, dead limbs, poor structure, moderate lean, remove tree	
	<i>Robinia pseudoacacia</i>	Black Locust	51	30	Poor	dead limbs, moderate lean, some rot decay, cavity present, remove tree	
4	<i>Fraxinus pennsylvanica</i>	Green Ash	8	10	Fair	vines, bark damage, dead limbs (prune to maintain)	Plot 4 (Non-woodland) exhibited fair and good conditions and was primarily dominated by an understory (<6" DBH) comprised of green ash and black cherry approximately 3" to 4" DBH. Although Plot 2 had trees greater than 6" DBH, they did not make up more than 50% of the total canopy coverage. See Photographs 13-16.

**Photo 13:** Overview of Plot 4 (Non-Woodland), facing north.

**Photo 14:** Overview of Plot 4 (Non-Woodland), facing east.

**Photo 15:** Overview of Plot 4 (Non-Woodland), facing south.

**Photo 16:** Overview of Plot 4 (Non-Woodland), facing west.

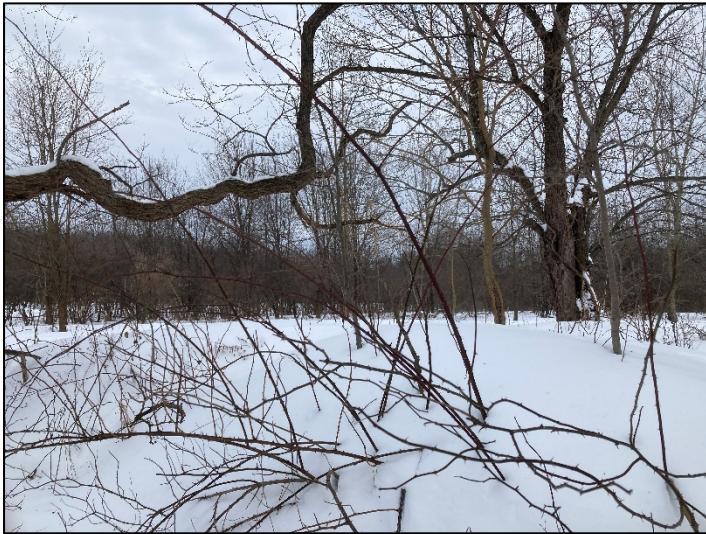
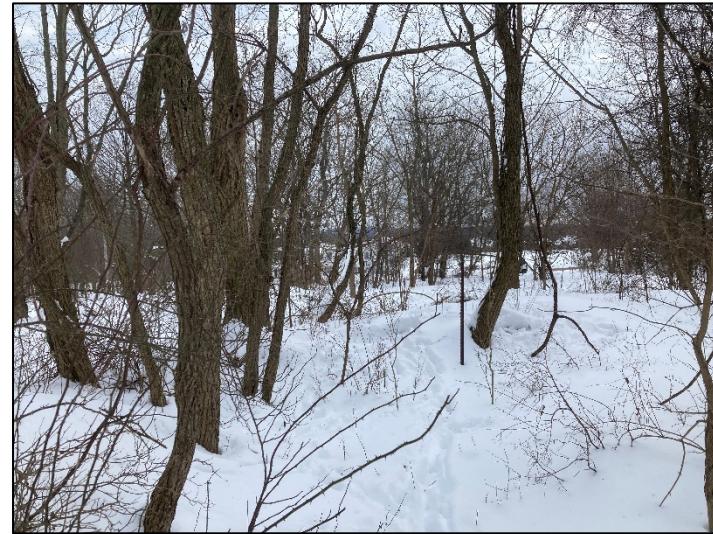
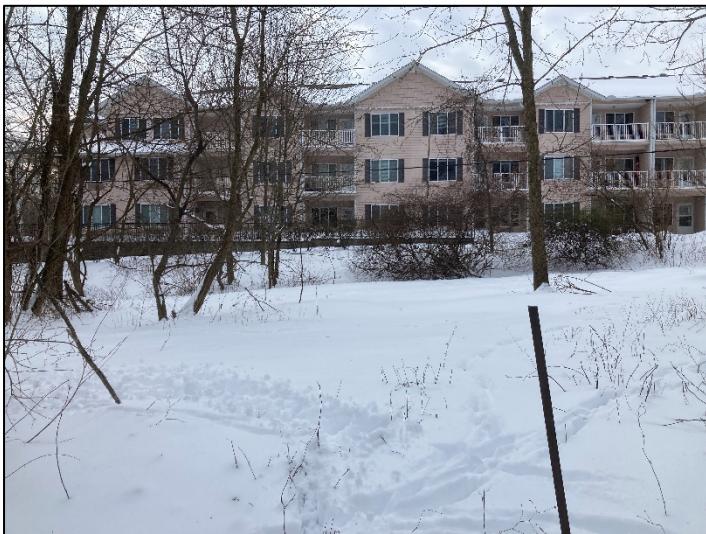
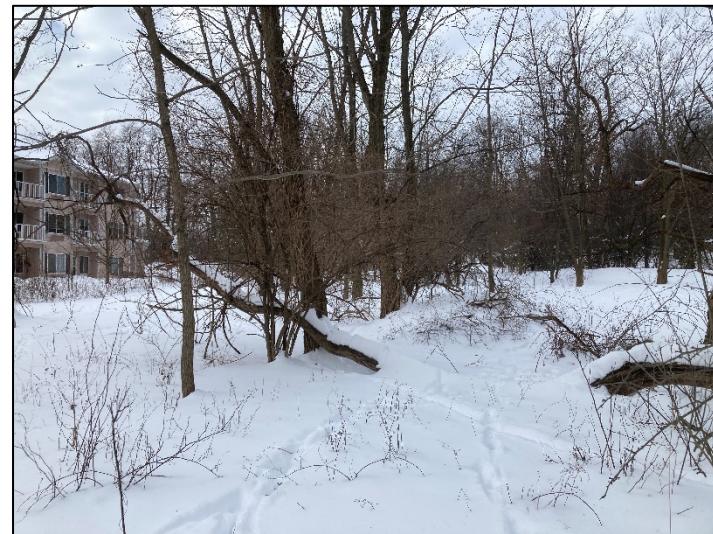
**Photo 17:** Overview of Plot 5 (Woodland), facing north.

**Photo 18:** Overview of Plot 5 (Woodland), facing east.

**Photo 19:** Overview of Plot 5 (Woodland), facing south.

**Photo 20:** Overview of Plot 5 (Woodland), facing west.

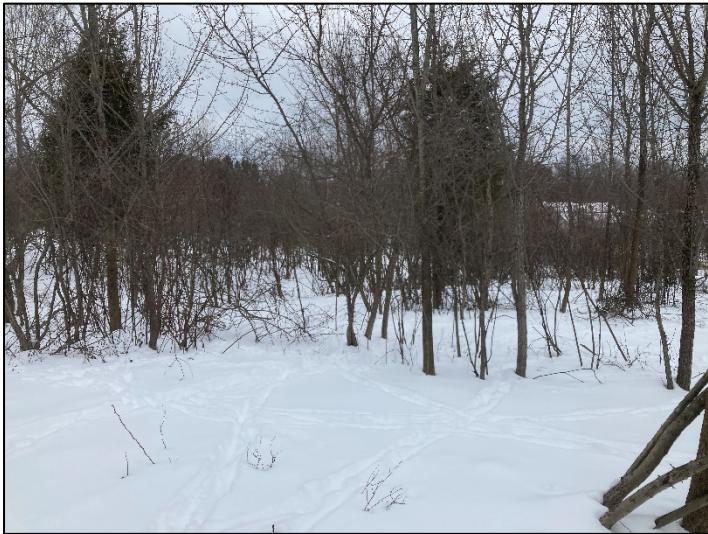
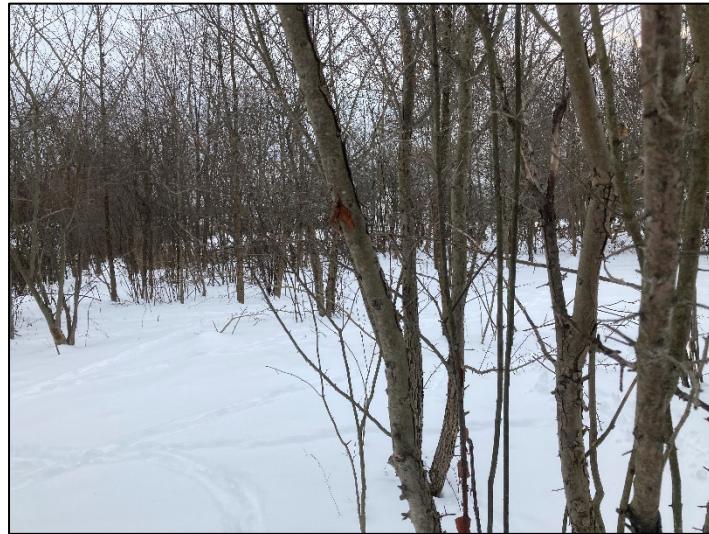
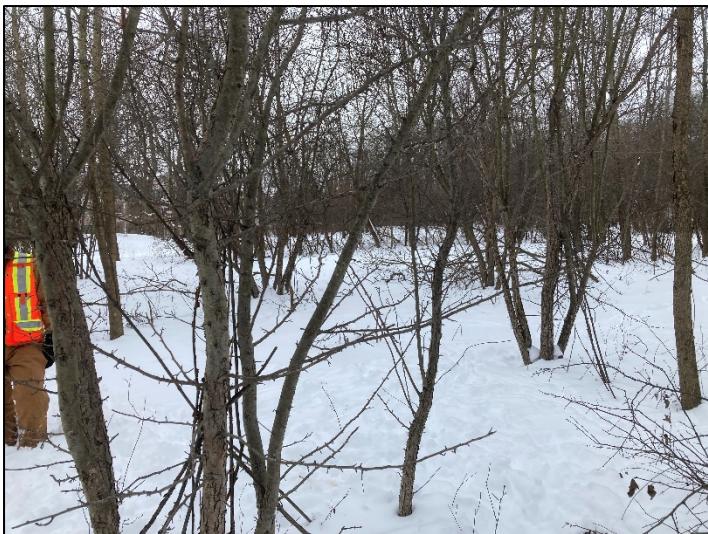
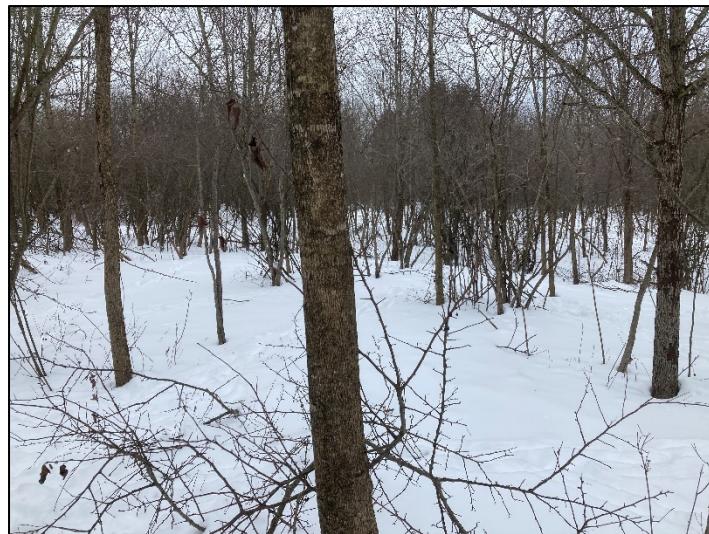
**Photo 21:** Overview of Plot 6 (Non-Woodland), facing north.

**Photo 22:** Overview of Plot 6 (Non-Woodland), facing east.

**Photo 23:** Overview of Plot 6 (Non-Woodland), facing south.

**Photo 24:** Overview of Plot 6 (Non-Woodland), facing west.

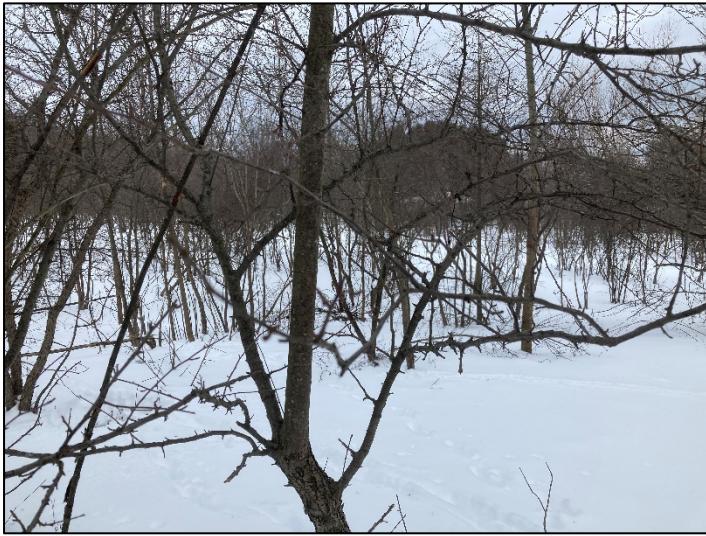
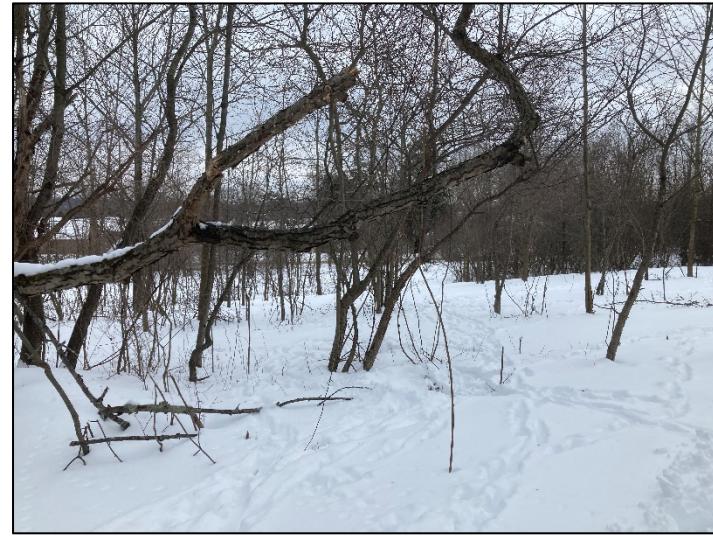
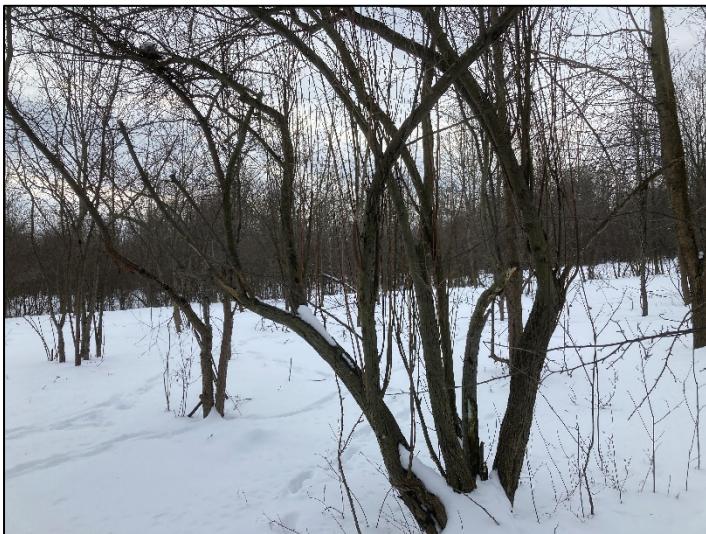
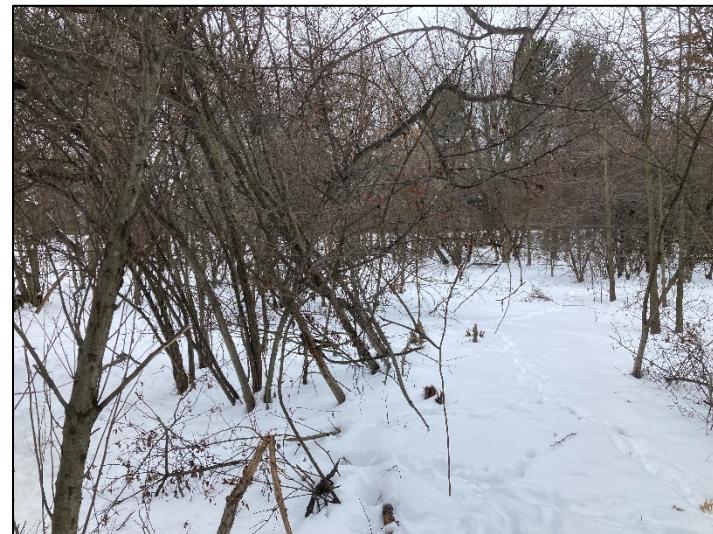
<i>Robinia pseudoacacia</i>	Black Locust	9	12	Fair	vines, dead limbs (prune to maintain), slight lean	
	<i>Robinia pseudoacacia</i>	Black Locust	7	10	Fair	vines, slight lean	
	<i>Robinia pseudoacacia</i>	Black Locust	25	18	Poor	bark damage, dead limbs, water sprouts, moderate lean, remove tree	
6	<i>Fraxinus pennsylvanica</i>	Green Ash	7	12	Good		Plot 6 (Non-woodland) exhibited fair conditions and was primarily dominated by an understory (<6" DBH) comprised of green ash and crab apple approximately 2" to 4" DBH. Although Plot 2 had trees greater than 6" DBH, they did not make up more than 50% of the total canopy coverage. See Photographs 21-24.
	<i>Fraxinus pennsylvanica</i>	Green Ash	6	10	Good		
7	<i>Prunus serotina</i>	Black Cherry	24	15	Poor	vines, dead limbs, moderate lean, multi-trunked	Plot 7 (Non-woodland) exhibited poor and fair conditions and was primarily dominated by an understory (<6" DBH) comprised of American elm and crab apple approximately 2" to 4" DBH. Although Plot 2 had trees greater than 6" DBH, they did not make up more than 50% of the total canopy coverage. See Photographs 25-28.

**Photo 25:** Overview of Plot 7 (Non-Woodland), facing north.

**Photo 26:** Overview Plot 7 (Non-Woodland), facing east.

**Photo 27:** Overview of Plot 7 (Non-Woodland), facing south.

**Photo 28:** Overview of Plot 7 (Non-Woodland), facing west.

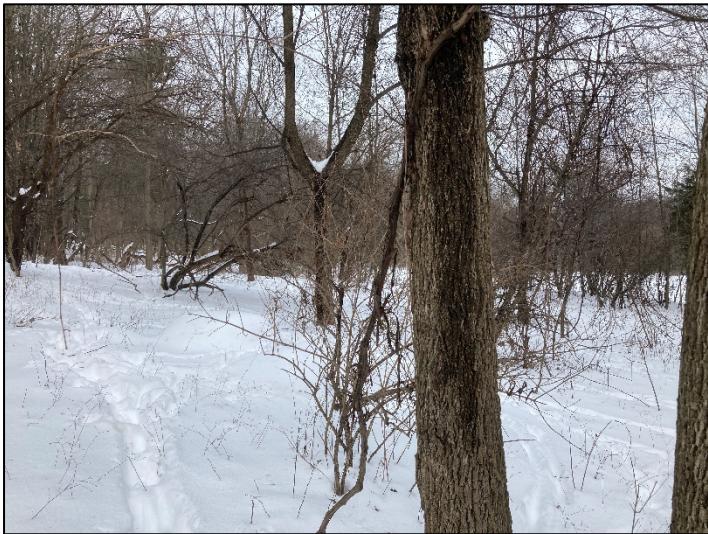
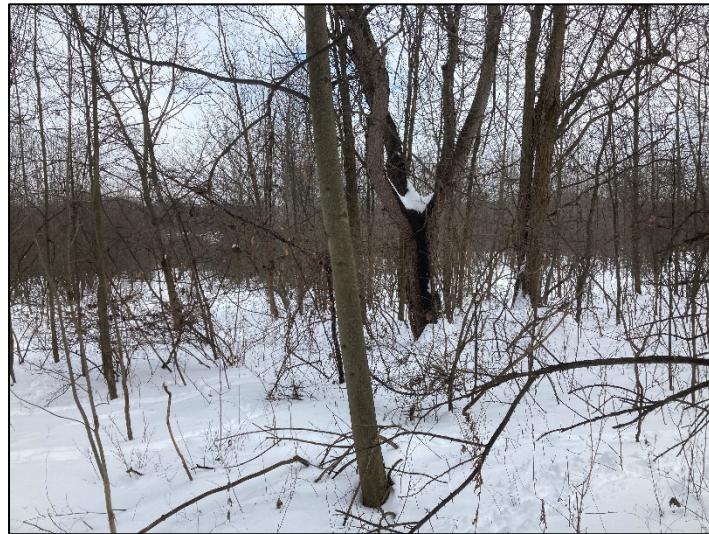
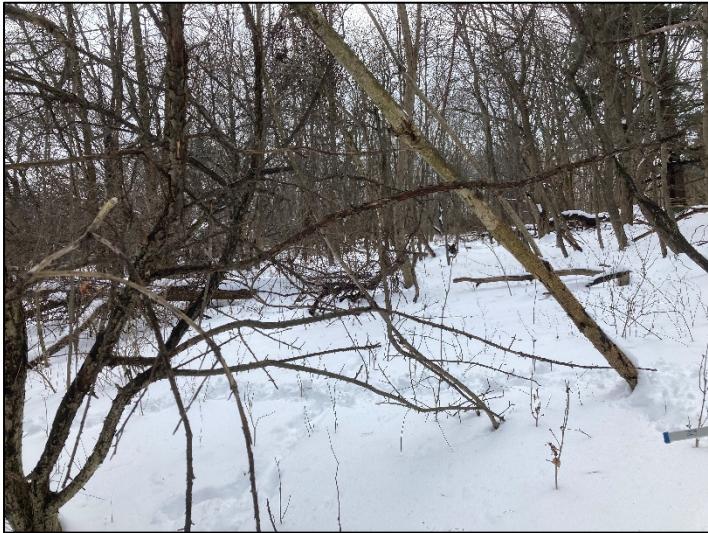
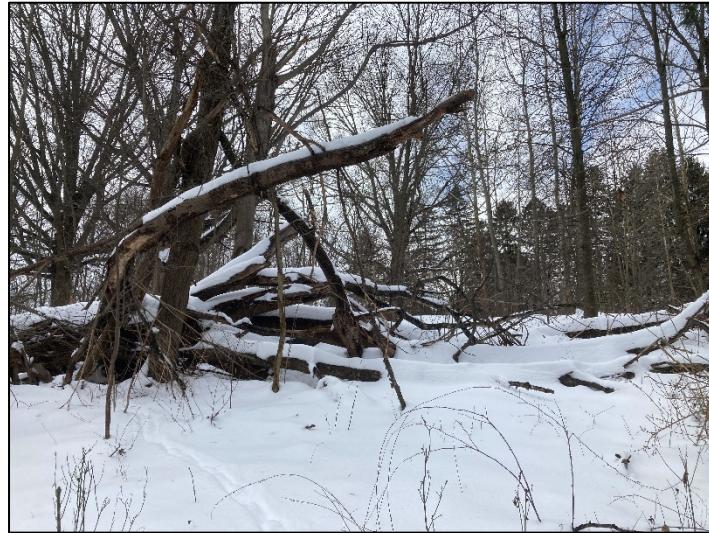
**Photo 29:** Overview of Plot 8 (Woodland), facing north.

**Photo 30:** Overview of Plot 8 (Woodland), facing east.

**Photo 31:** Overview of Plot 8 (Woodland), facing south.

**Photo 32:** Overview of Plot 8 (Woodland), facing west.

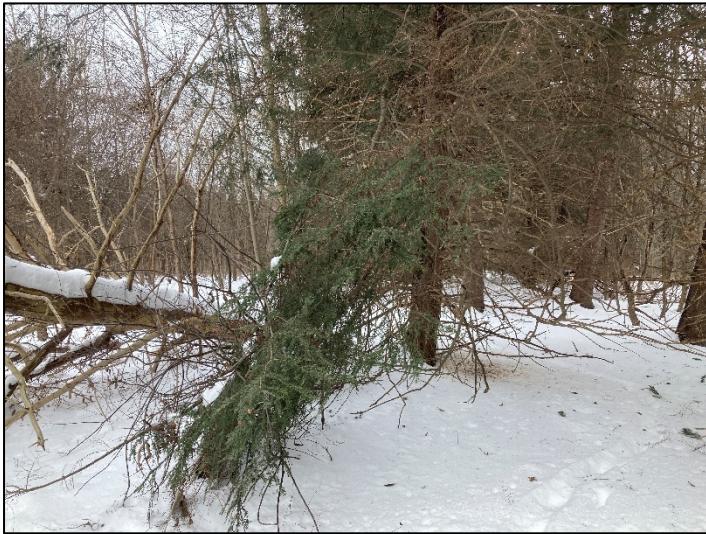
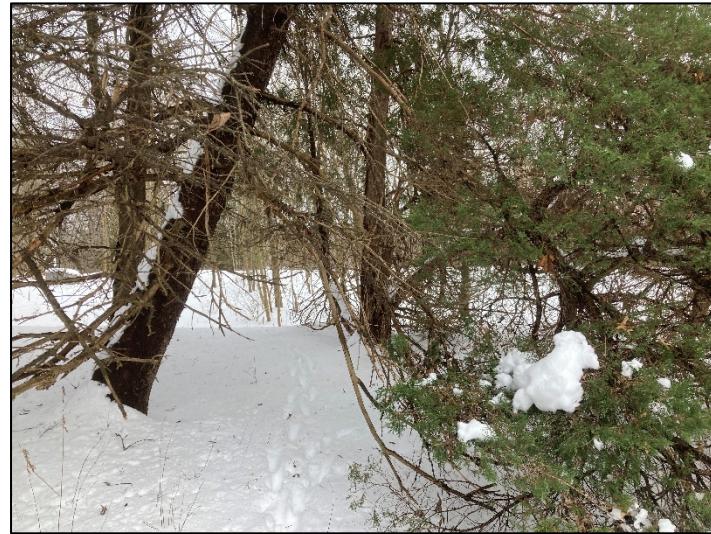
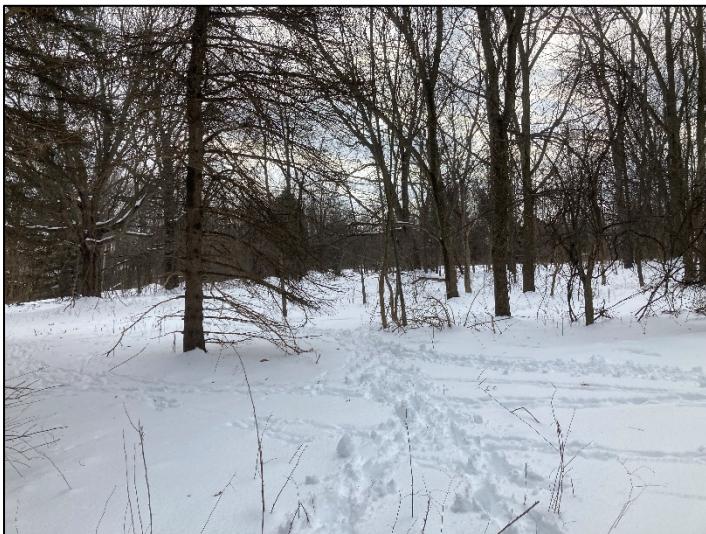
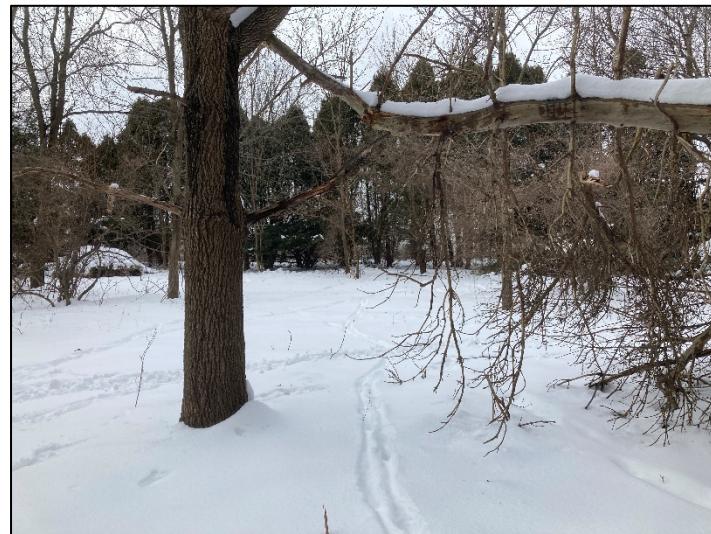
**Photo 33:** Overview of Plot 9 (Woodland), facing north.

**Photo 34:** Overview of Plot 9 (Woodland), facing east.

**Photo 35:** Overview of Plot 9 (Woodland), facing south.

**Photo 36:** Overview of Plot 9 (Woodland), facing west.

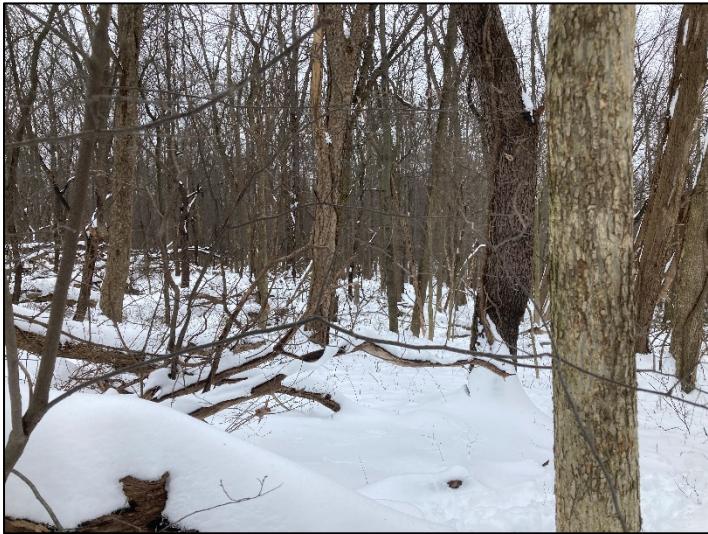
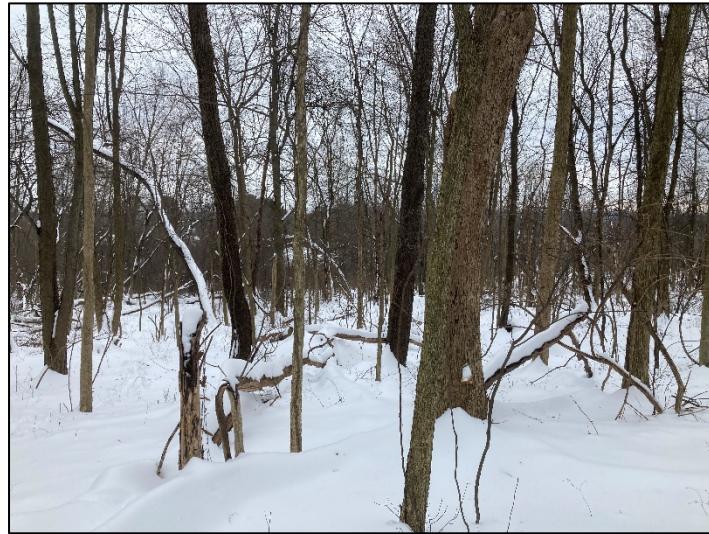
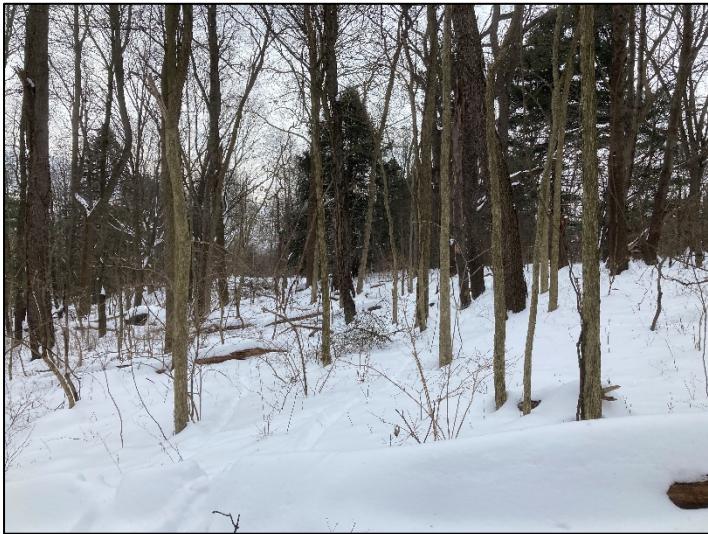
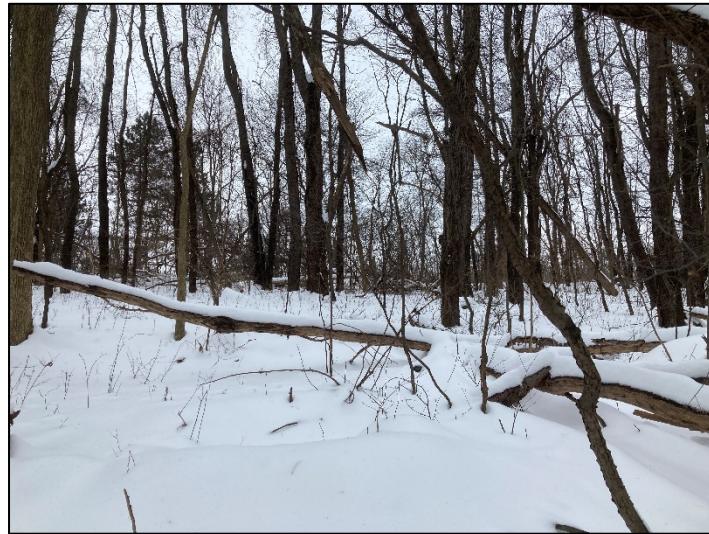
9	<i>Robinia pseudoacacia</i>	Black Locust	10	20	Fair	vines, dead limbs (prune to maintain)	Plot 9 (Woodland) exhibited poor to good conditions and was primarily dominated by white spruce, which made up more than 50% of the total canopy coverage. The understory (<6" DBH) was primarily comprised of <i>Rubus</i> sp. See Photographs 33-36.
	<i>Juglans nigra</i>	Black Walnut	23	30	Good	few dead limbs (prune to maintain)	
	<i>Picea glauca</i>	White Spruce	17	25	Fair	dead limbs (prune to maintain), poor structure	
	<i>Picea glauca</i>	White Spruce	13	20	Fair	dead limbs (prune to maintain), moderate lean	
	<i>Picea glauca</i>	White Spruce	13	15	Poor	dead limbs, high lean, remove tree	
	<i>Picea glauca</i>	White Spruce	16	15	Poor	dead limbs, high lean, remove tree	
10	<i>Thuja occidentalis</i>	White Cedar	13	15	Fair	dead limbs (prune to maintain), moderate lean	Plot 10 (Woodland) exhibited poor and fair conditions and was primarily dominated by American elm, which made up more than 50% of the total canopy coverage. The understory (<6" DBH) was primarily comprised of American beech and Japanese honeysuckle approximately 1" to 3" DBH, and <i>Rubus</i> sp. See Photographs 37-40.

**Photo 37:** Overview of Plot 10 (Woodland), facing north.

**Photo 38:** Overview of Plot 10 (Woodland), facing east.

**Photo 39:** Overview of Plot 10 (Woodland), facing south.

**Photo 40:** Overview of Plot 10 (Woodland), facing west.

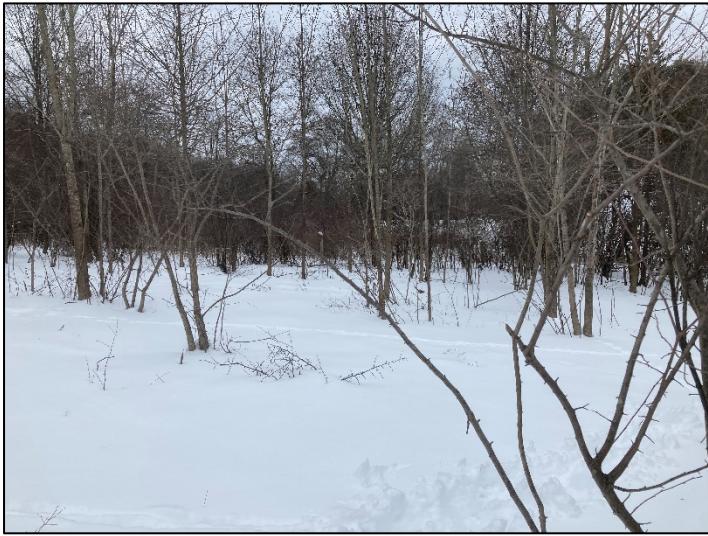
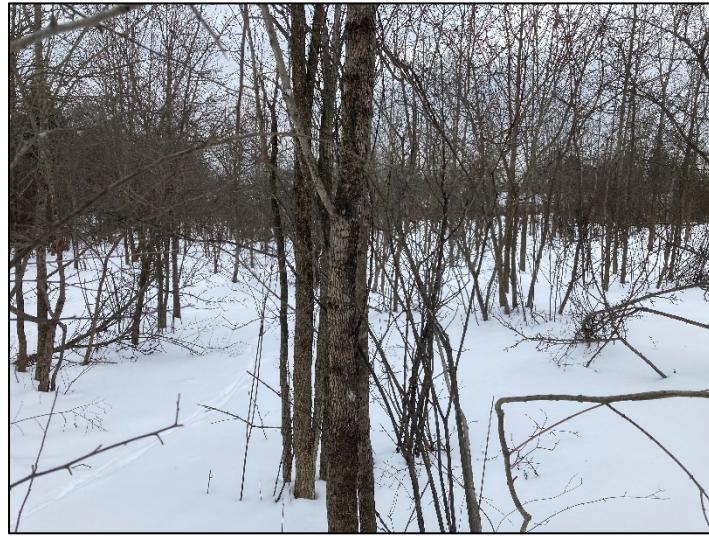
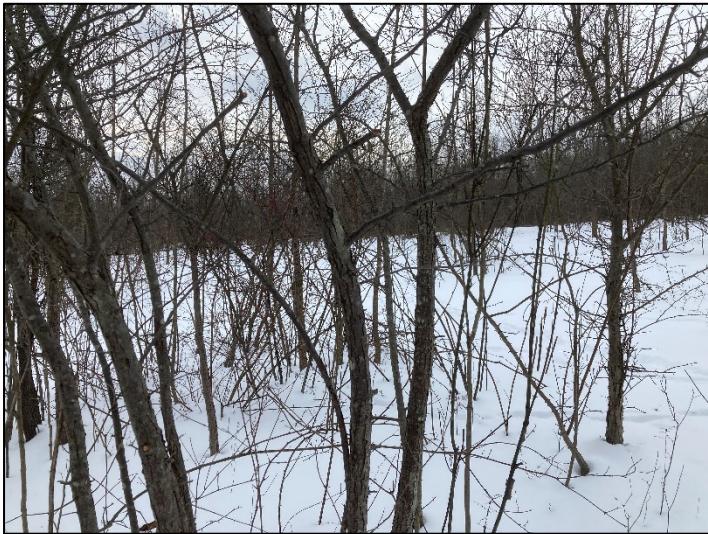
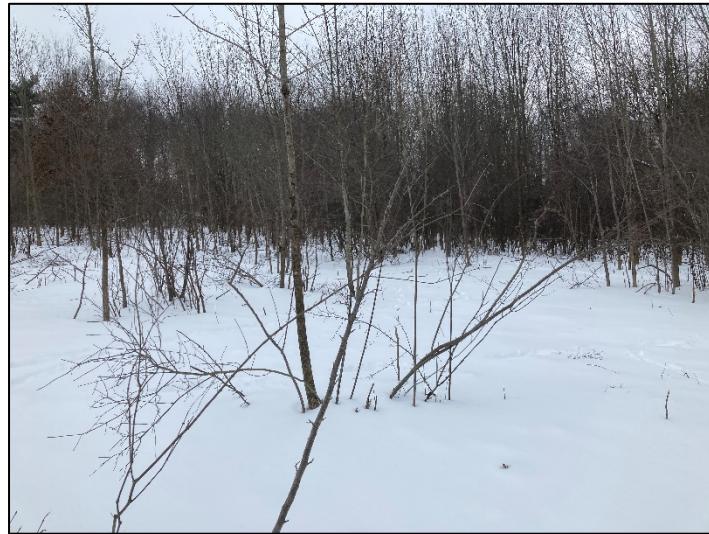
**Photo 41:** Overview of Plot 11 (Non-Woodland), facing north.

**Photo 42:** Overview of Plot 11 (Non-Woodland), facing east.

**Photo 43:** Overview of Plot 11 (Non-Woodland), facing south.

**Photo 44:** Overview of Plot 11 (Non-Woodland), facing west.
